CHINA, EAST COAST—HAN RIVER ENTRANCE.

Port Swatow—Wreck marked by Light-Buoy.

The Calcutta Gazette

WEDNESDAY, AUGUST 30, 1922.

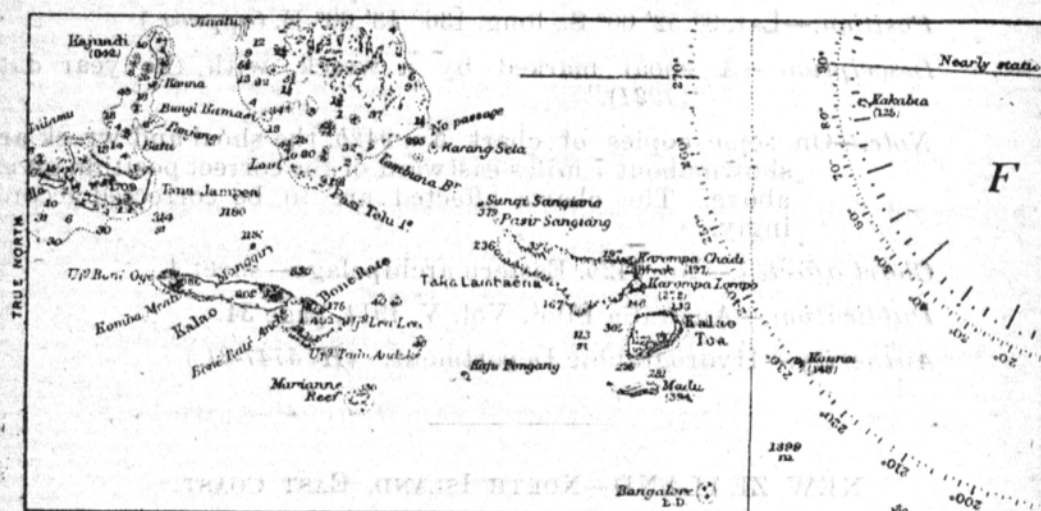
Reproduction of Portion of Chart N° 942a.

Note.—On some copies of chart No. 942b, the shoal and wreck are shown about 7 miles eastward of the correct position given above. The charts affected are to be corrected accordingly.
